Manhole Inspection Summary

Manhole # S45GG_050MH

Insp Date: **3/12/08 10:25 AM**

Location Address: **Wolfe**

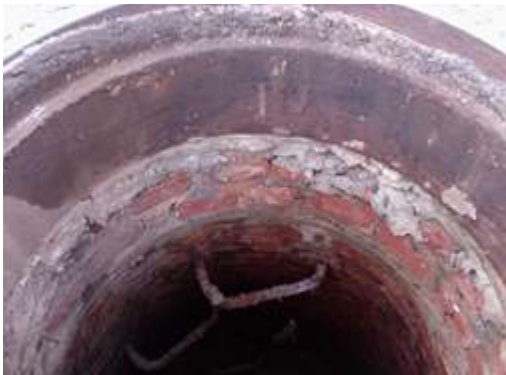
Defect 1

Infiltration: ☐ None ☐ Joint ☐ Cracks ☒ **Mortar** ☐ Roots ☒ **Wall**

adjustment joint

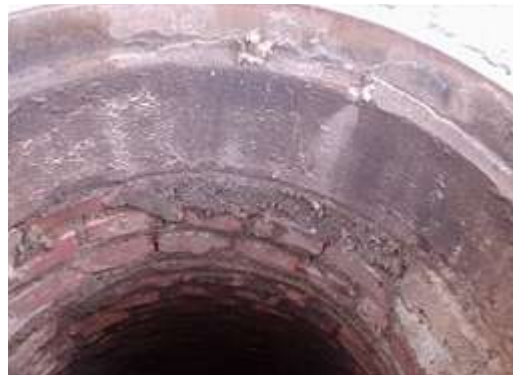
Defect 2

☒ **Leaks**

frame leaks.

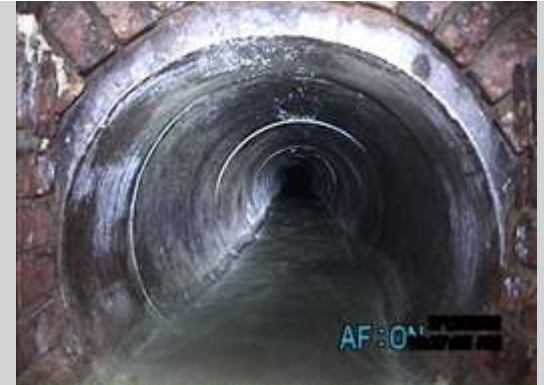
12 O'Clock Outflow

Pipe Height: **21.6** (in.) Rod and Bar (Angled)
Pipe Material: **Clay** ☐ Pipe Lined
Invert Depth: **10.95** (ft.) Flow Characteristics: **Fast**
Deposits: ☒ None ☐ Mud ☐ Sludge ☐ Debris ☐ Grease
Silt Depth: (in.) Deposits Extent:
Infiltration: **None** Pipe Seal Cond: **Sound**

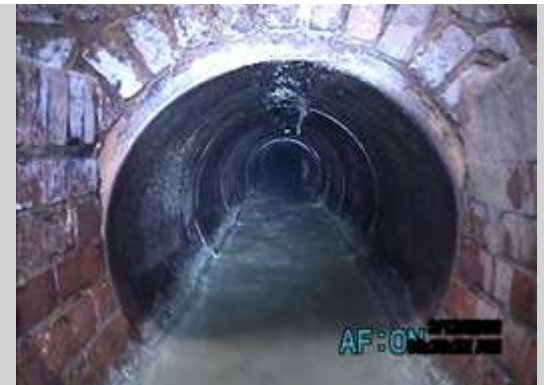
6 O'Clock Inflow

Pipe Height: **21.6** (in.) Rod and Bar (Angled)
Pipe Material: **Clay** ☐ Pipe Lined
Invert Depth: **10.90** (ft.) Flow Characteristics: **Fast**
Deposits: ☒ None ☐ Mud ☐ Sludge ☐ Debris ☐ Grease
Silt Depth: (in.) Deposits Extent:
Infiltration: **None** Pipe Seal Cond: **Sound**

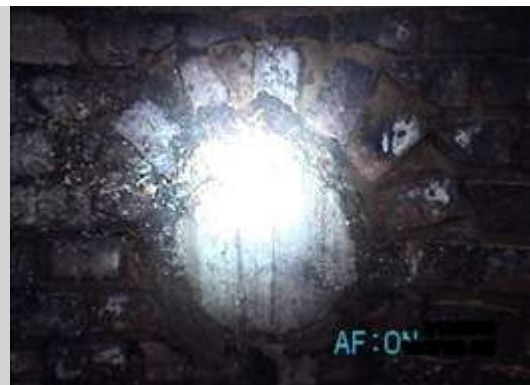
Pipe In @ 9 O'Clock

Sealed with concrete.

Deposits: ☐ None ☒ **Mud** ☒ **Sludge** ☒ **Debris** ☐ Grease

Silt Depth: **8** (in.) Deposits Extent: **Heavy**

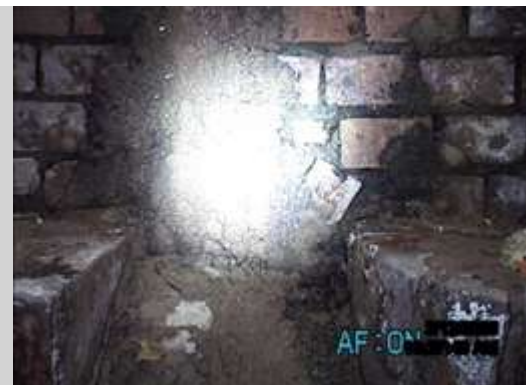
Drop In @ 9 O'Clock

Sealed with concrete.

Drop: Inside	Rod and Bar
Angled: Yes	Reading: 8.80 (ft.)
	Inv Depth: 9.80 (ft.)
Drop Condition: Clogged
